## **The Effect of Bird Streamers on the Insulation Strength of HVDC Lines**

### **SUMMARY**

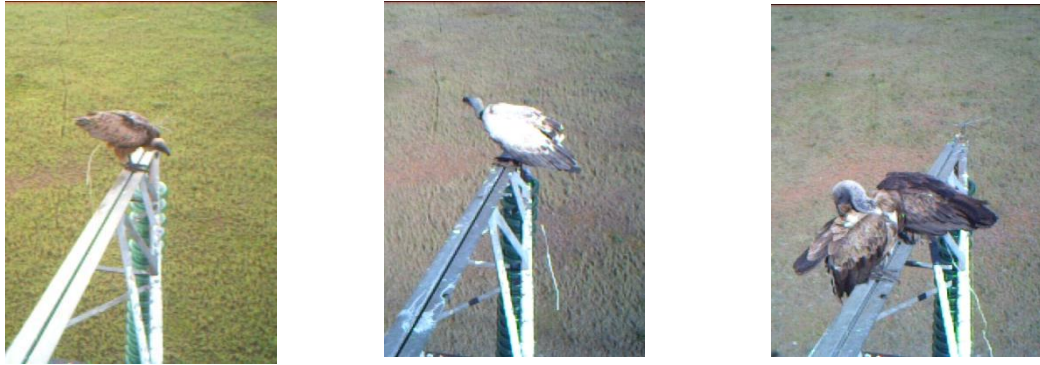
In South Africa, vultures are drawn to areas where the Cahora Bassa HVDC transmission line passes close to spots known as “vulture restaurants” or on farms where both wild and domestic animals present a food source. Artificial feeding areas are created where livestock farmers dispose of carcasses of dead animals, which the vultures feed on. After eating their fill during the day, these birds then perch on the line’s pylons. During the night or early morning it releases a streamer, which if directed into an electrically vulnerable area, may lead to a flashover of the line. Vultures are not the only type of bird that is known to utilise the pylons, and many other large birds have also been observed perching on them (see Figure 1). Figure 2, shows birds in the act of streaming on the top of the pylon. The streamers captured in Figure 2, did not cause a fault event. Due to the angle of the camera installation it was not possible to determine the lengths of the streamers shown in Figure 2.

**Figure 2: Large birds releasing streamers on top of a HVDC transmission line**

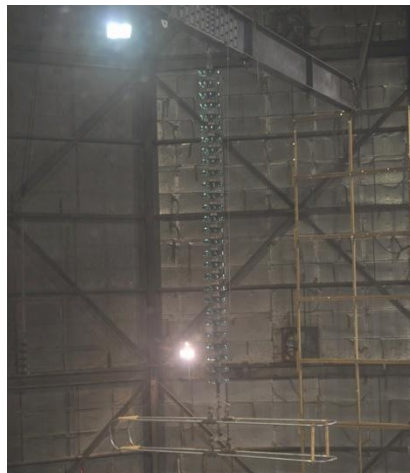
A test programme was developed in order to try to better understand the fault mechanism and hence to propose mitigation measures so that the problem may be adequately managed. Tests were done at both the National Electrical Testing Facility's (NETFA) high voltage laboratory in Midrand, South Africa, and at the Electric Power Research Institute's (EPRI) high voltage laboratory in Lenox, USA. The Cahora Bassa HVDC line pylon structure was replicated in both the laboratories (see Figure 3). A bird streamer replicator device was developed to simulate the condition. The tests were done at a representative +533 kV voltage. A HVDC glass cap and pin insulator string consisting of 28 insulators was used. The connecting length was 4.5 m. The test programme involved simulating bird streamers occurring at various positions in the space between the pylon, the insulator and the live transmission line. The EPRI tests were done under controlled temperatures which are applicable to local conditions in South Africa. The tests were therefore done indoors. This allowed the room test temperature to be controlled by heating the test building.

**Figure 3: A replica of the Cahora Bassa pylon dimensions in the EPRI HV laboratory**

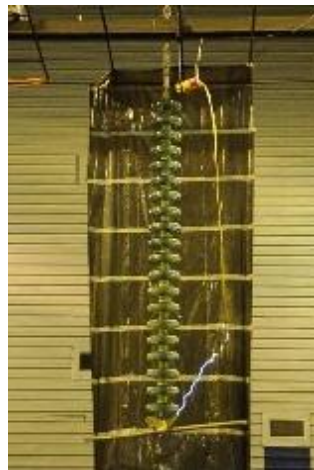
Figure 6, shows a flashover event during the South African tests, at the SABS NETFA HV laboratory. A gravity feed technique was used in this test as part of the investigation into the volume and size of the streamer required for a flashover.

**Figure 6: Flashover observed at 30 cm away from the string (NETFA Lab)**

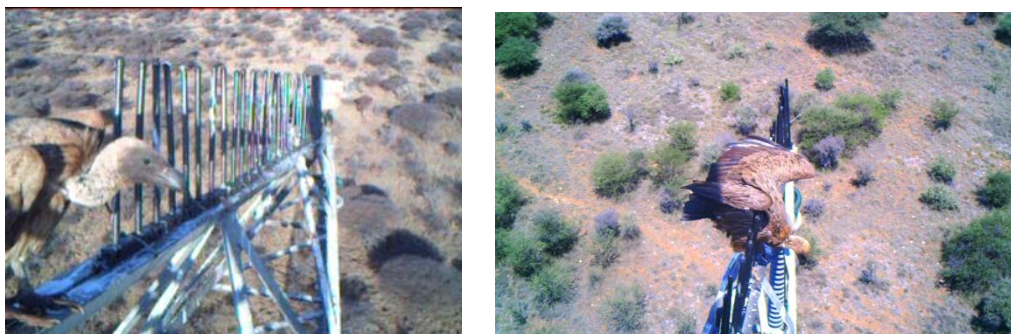
Figure 8, shows a bird guard installation of approximately 2m in length. It has been observed that the larger birds are still able to roost on this device, and within the critical position away from the insulator string. Further, as seen in the image on the left (in Figure 8), there is an entire section at the bottom of the cross-arm (which is located in the critical area away from the insulator) that is left unprotected. Birds may be able to access this area. The physical installation and placement of the bird guards will therefore have to be further investigated.

**Figure 8: Bird behavior around bird guards**

In lieu of mitigation of this problem, a solution known as ‘bird guards’ may be applicable. Bird guards are a finger-like apparatus that is made from UV resistant high-density polyethylene. Bird guards have been installed on South African transmission lines as well as in the USA with the purpose of safely keeping birds away from critical/vulnerable areas on the pylon (i.e. in order to prevent streamers to bridge-out the electrical clearance)[10]. These devices were considered successful in preventing streamer faults and during the initial installations, it reduced the number of faults from 450 per annum, in 1999, to 250 at the end of 2001 [3].
